CASE STUDY

Utqiaģvik, Alaska THE CHALLENGE

Ukpeaġvik Iñupiat Corporation (UIC)

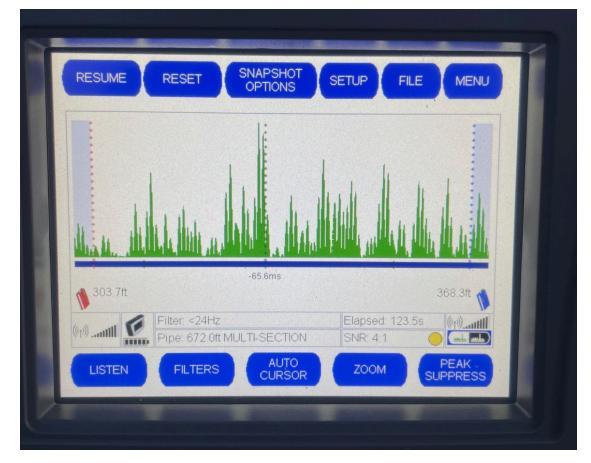
The community's water distribution system faced unique challenges due to its recirculating design. Leaks were transferred from barrel to barrel at residences, complicating direct detection. To track and isolate leak locations, recirculation pumps were bypassed to reduce background noise.

Technicians effectively detected and traced leak sounds using the Tri-Corr Touch Pro Correlator paired with a Hydrophone Kit. The process was further enhanced by the intentional creation of manufactured leaks from barrels, which served as reference points to aid accurate tracking.
